Oregon Department of Transportation – Rail Division

**Oregon Rail Study Appendix B**  
**Oregon Rail Bridge Assessments,**  
**Report of Study Findings**

- *Oregon Rail Bridge Assessments  
ATA No. 25159, WOC No. 11*

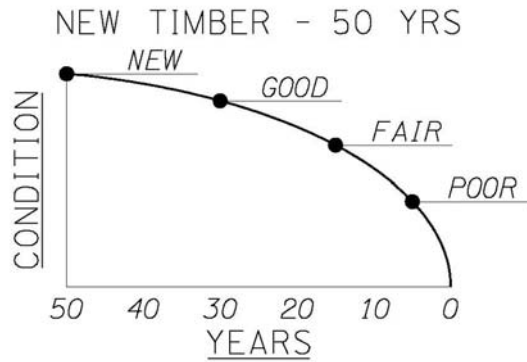
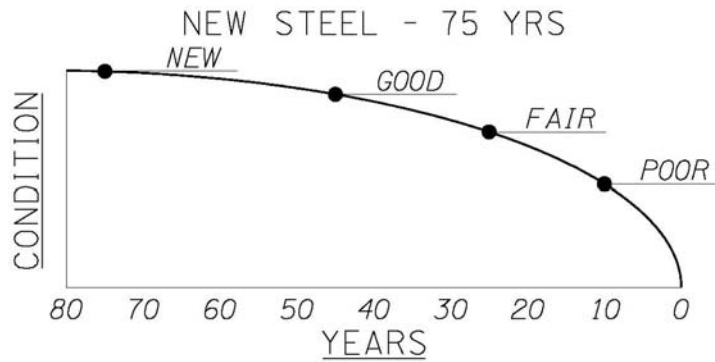
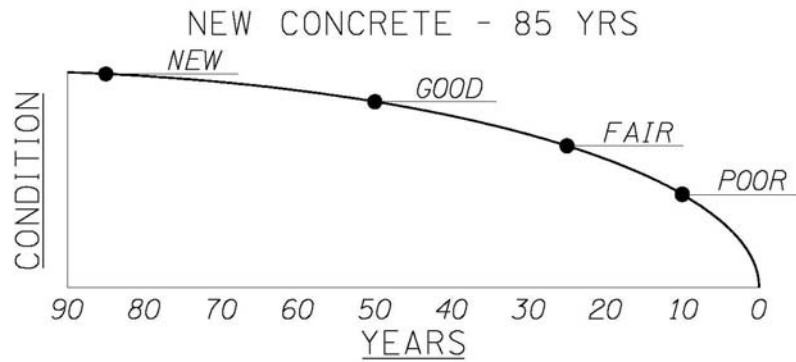
As the deterioration of material progresses with time, the rate of condition change is estimated to increase. That is, the period of time to change condition from fair to poor is less than that to change from good to fair. As protective systems or mechanisms reach their life expectancy, the exposure of the bridge member to deteriorating elements is increased. For example, as the creosote protective system on a timber member weathers and breaks down, or cracks and splits break through to the untreated core of the member, its exposure to decay causing fungi is increased and the rate of deterioration is accelerated.

The three graphs below illustrate the varying degree and rate of deterioration based on material and remaining lifespan.

The primary factor associated with the life of timber is the deterioration by decay, both from rot and insect infestation, with breakage being a lesser factor. Deterioration of the steel in bridges was found to be mainly due to the paint system failure and the subsequent corrosion and section loss in members. Concrete deterioration is generally associated with cracking and spalling with exposure of reinforcing steel that corrodes and fosters progressive cracking and spalling.
